Manhole Inspection Summary

Manhole # S25WW1043MH

Location Address: **5204 ROLAND AVE**

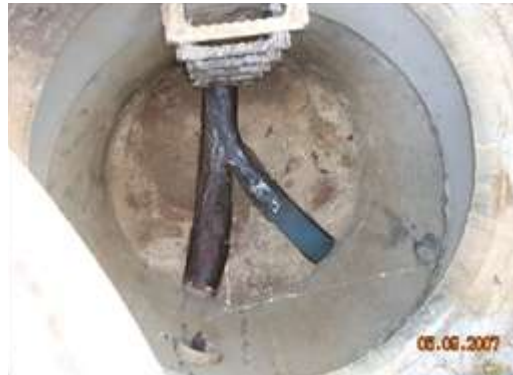
Top View

☐ Parged ☒ **Debris** (not Condition related)

Bench debris.

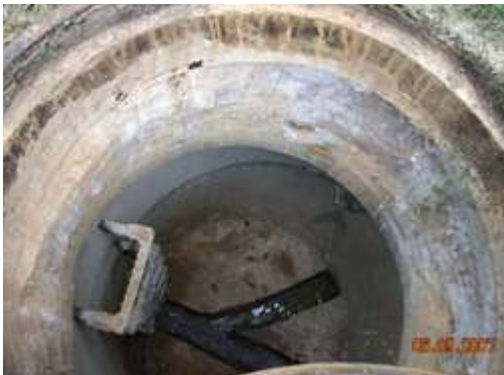
Defect

Infiltration: ☐ None ☒ **Joint** ☐ Cracks ☐ Mortar ☐ Roots ☒ **Wall**

Infiltration: ☐ None ☒ **Joint** ☐ Cracks ☐ Mortar ☐ Roots ☐ Wall

Adjustment, Corbel and Barrel infiltration.

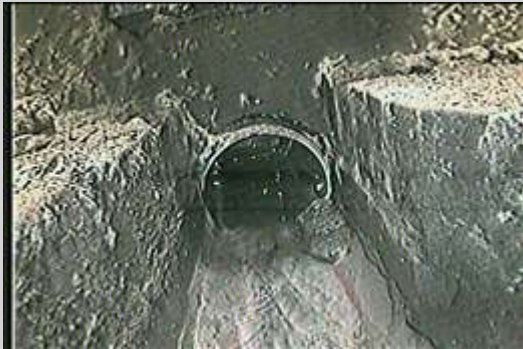
6 in. Circular Gravity Sewer Pipe Out @ 12 O'Clock

Condition: ☐ Sound ☒ **Cracked** ☐ Root Intrusion ☐ Deteriorated ☐ Leaks ☐ Debris

Channel cracks.

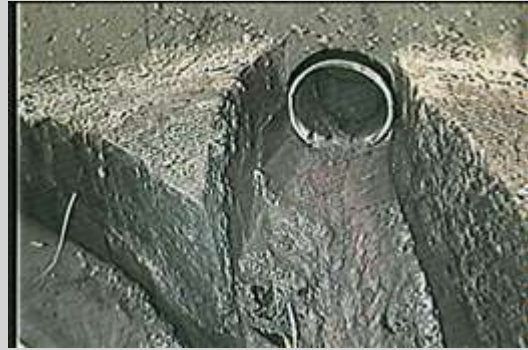
Drop In @ 6 O'Clock

Drop: **Outside** Rod and Bar

Drop Condition: **Open**
